MDM™ challenges CFA Foundation of Parking House

MDM™ Modified Dry Method

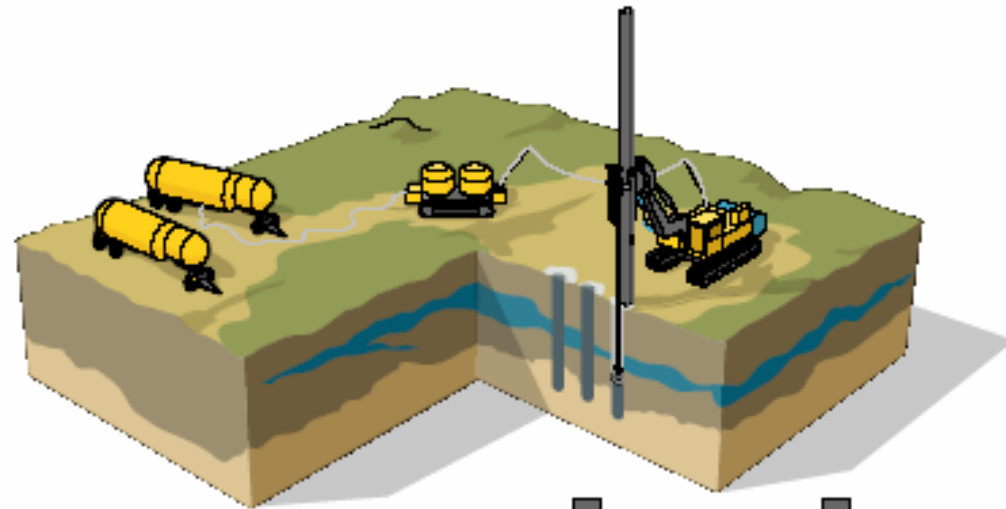
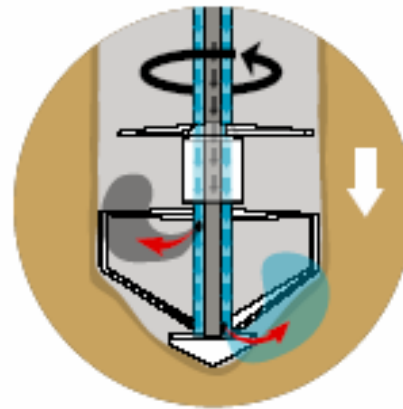
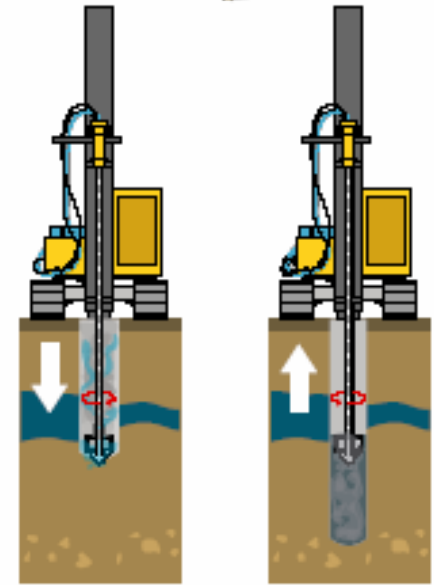
Logistics and Execution Principles

- Improves dry soils
- Penetrates stiff soils
- Optimizes mixability
- Activates the binder
- Minimizes spoil

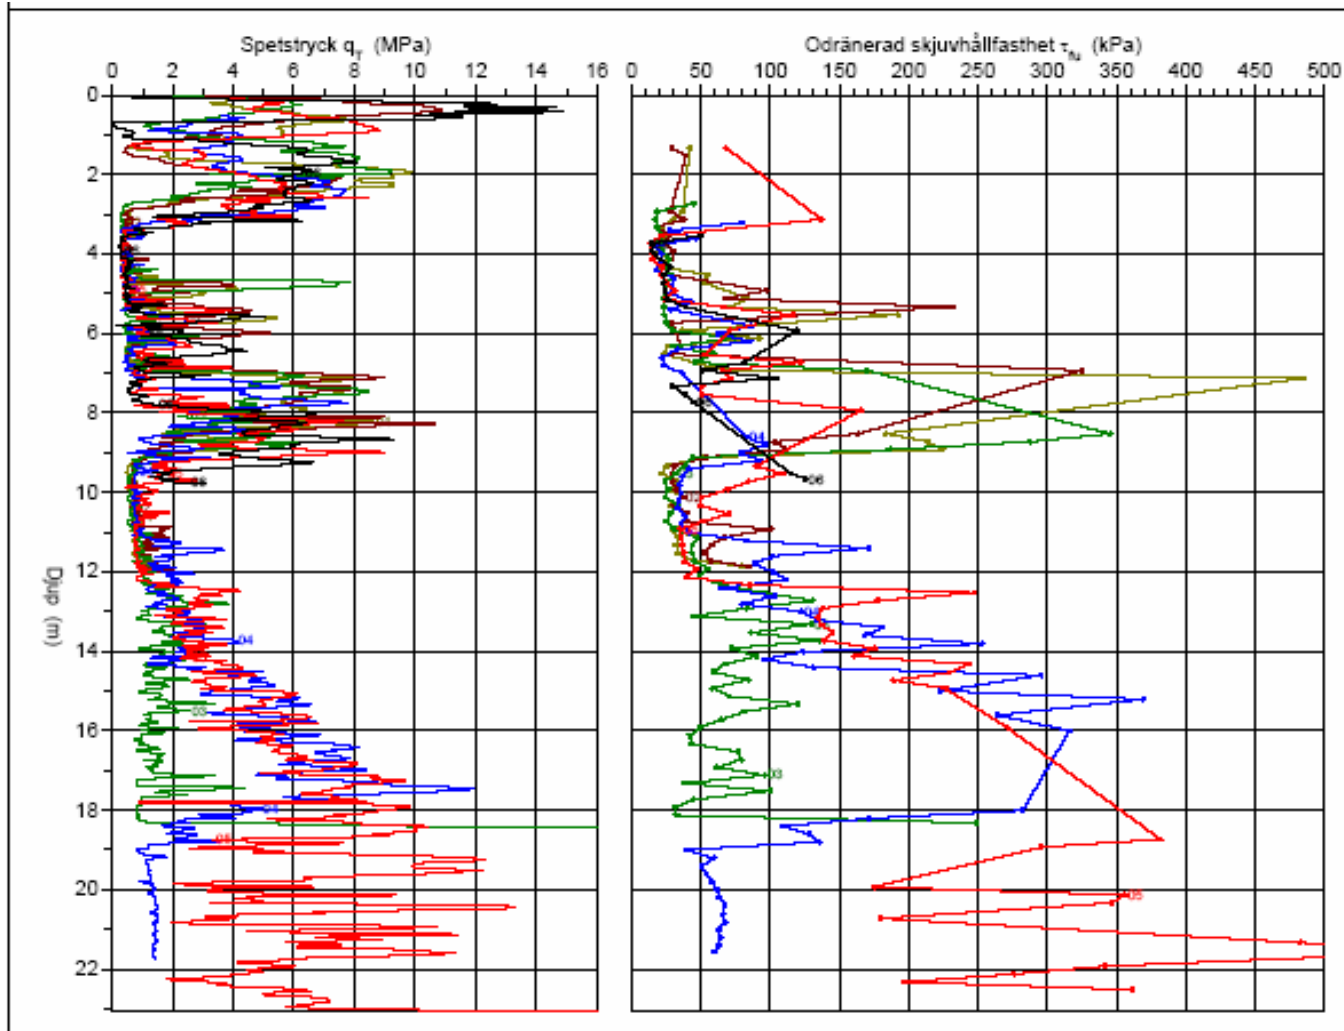
CPT – test results

Cone resistance

Undrained shear strength

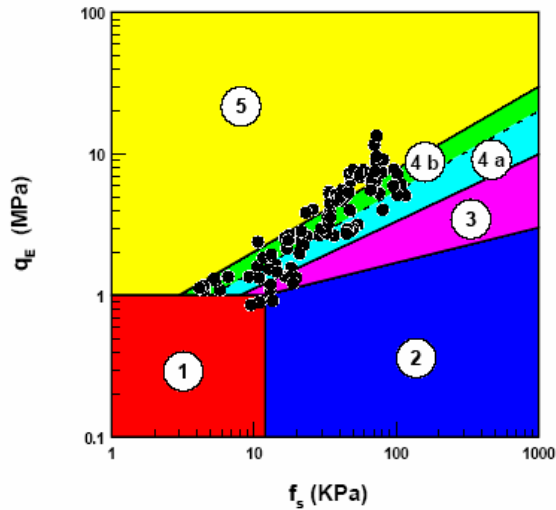
WSP 4A

Classification Chart
Eslami-Fellenius

- 1- Very Soft Clays – Sensitive Soils
- 2- Clays
- 3- Silty Clays – Stiff Clays
- 4- Sandy Silt and/or Silty Sand
 - a Sandy Silt and Silt
 - b Fine Sand and/or Silty Sand
- 5- Sands – Gravels

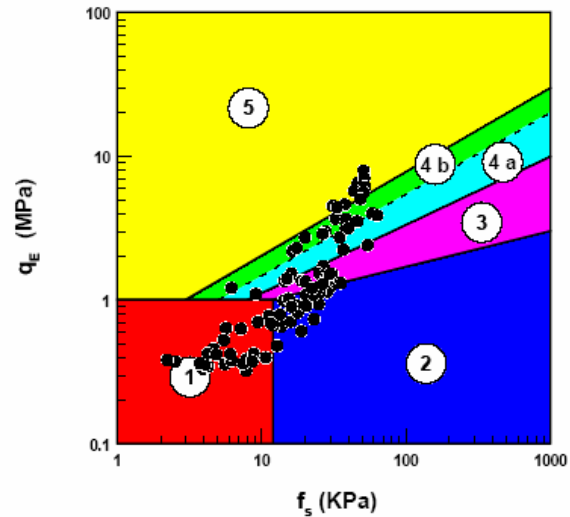
BH 3

Classification Chart
Eslami-Fellenius

- 1- Very Soft Clays – Sensitive Soils
- 2- Clays
- 3- Silty Clays – Stiff Clays
- 4- Sandy Silt and/or Silty Sand
 - a Sandy Silt and Silt
 - b Fine Sand and/or Silty Sand
- 5- Sands – Gravels

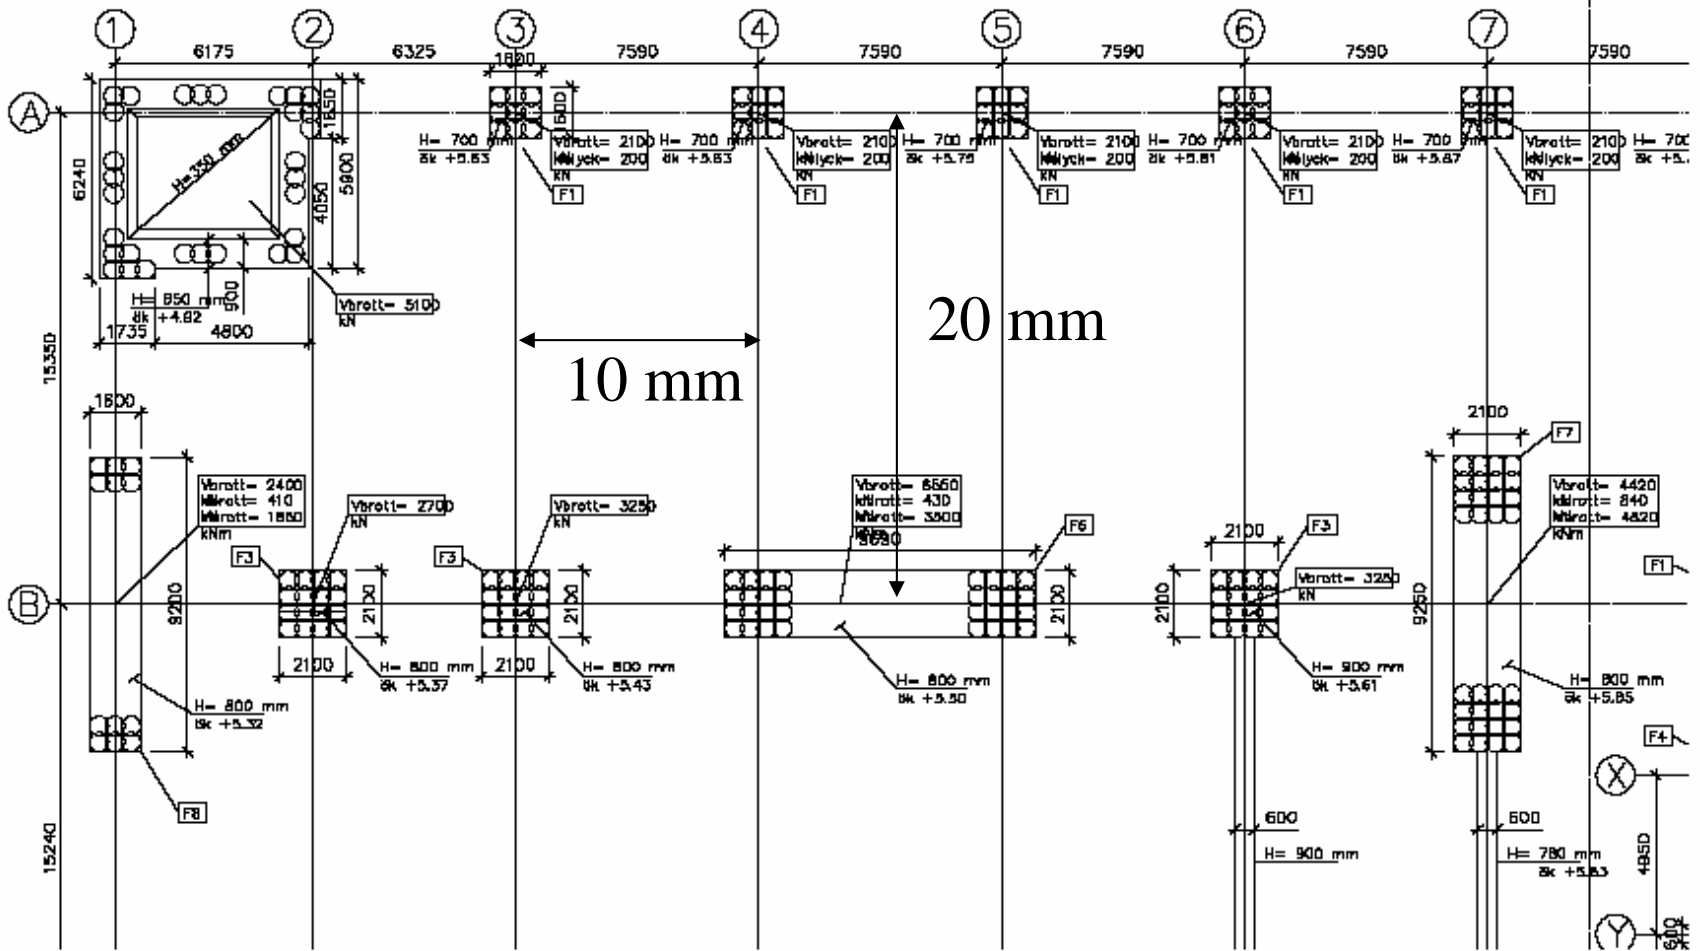
Design parameters

- Total settlement 40 mm
- Differential settlement 1:800
- Environmental impact

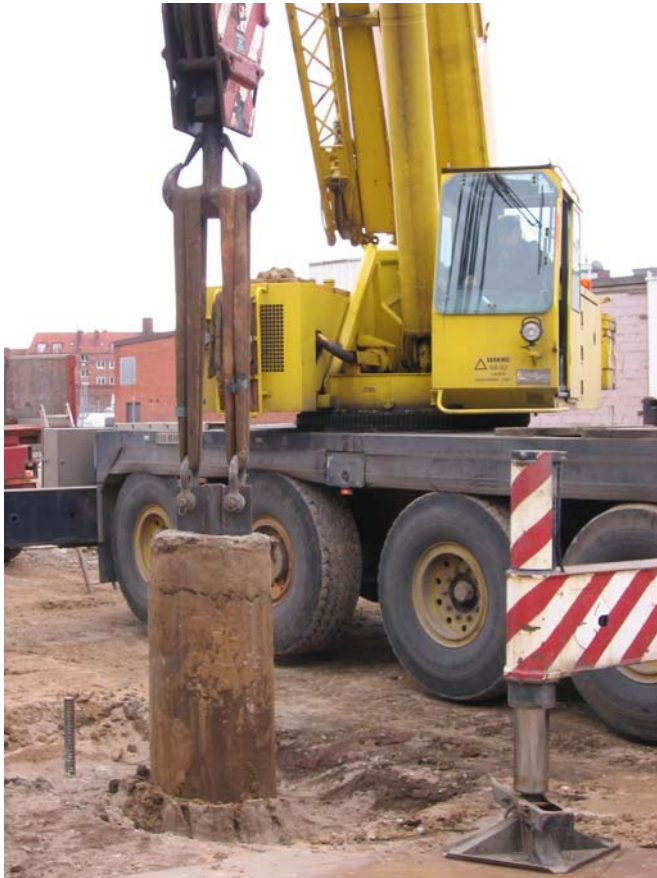
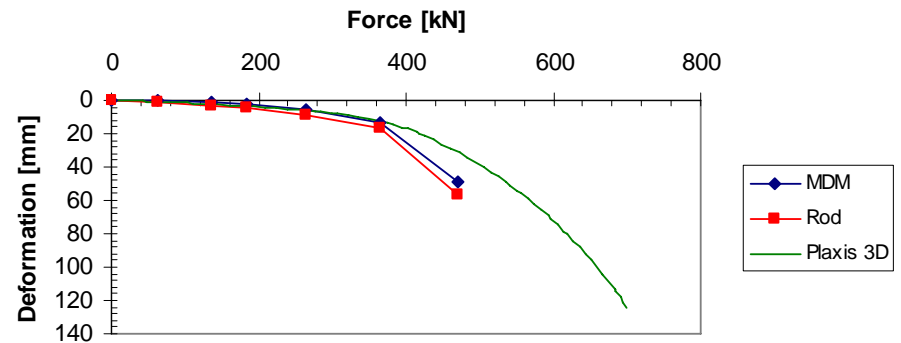
Extraction of columns – Static load test

- Pullout force 510 – 610 kN (114-137 kipf)
- Age 2 weeks
- Weight 45 kN (10kipf)
density 2.27 ton/m³
- Cohesion 39 – 46 kPa

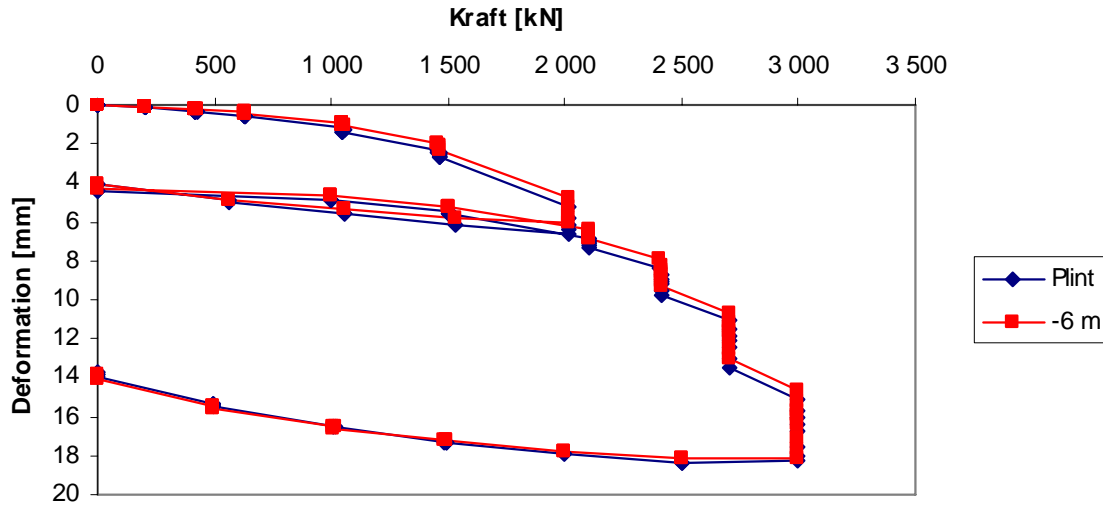
MDM block A-B/12

Static load test results

- 9 piles, 12 m long (net)
- 4 mm permanent deformation at 2100 kN (472 kipf)
- Secant modulus (2100 kN) – 2.5 GPa

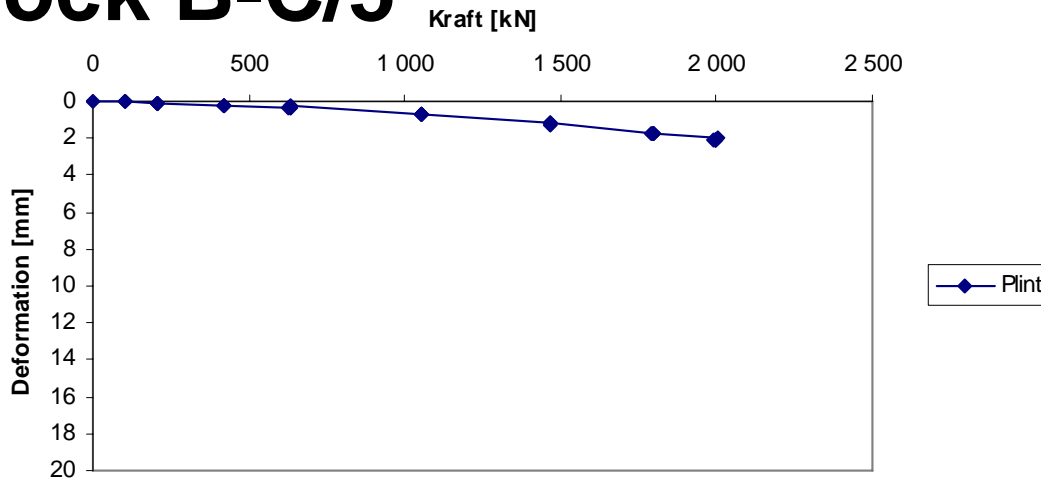
MDM block B-C/5

Static load test results

- 9 piles, 16 m long (net)
- No permanent deformation at 2100 kN (472 kipf)
- Secant modulus (2100 kN) – 6 GPa
- Titan tension piles pulled out at 2100 kN (472 kipf), test abandoned

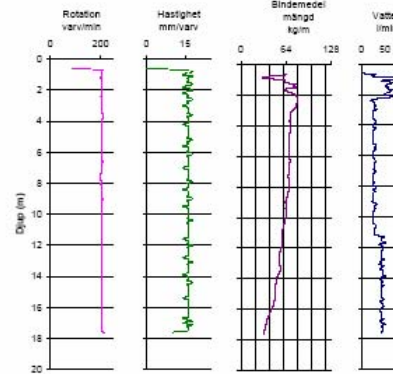
Borring nedåt

Projektnamn P-hus Gamle Tull
 Delområde Halmstad
 Beställare NCC

Pelarnr 01022-A.1
 Installationsdatum 4/18/2005
 Tid 9:29:51

Maskin KC-4
 Operatörer Svante-Bua-Martin

Verktyg diam [mm] 600
 Tot bindemedel [kg] 2112
 Luftryck medel [Mpa] 0.71
 Tot vatten [lit] 605.9

Borrat djup [m] 17.5
 Stabiliserat djup [m] 16.98
 Tomborring [m] 0.52

Rotation enl handl 200
 Bindemedel enl handl Cem III 64+64
 Stigning enl handl 15
 Verktyg enl handl 600 mm

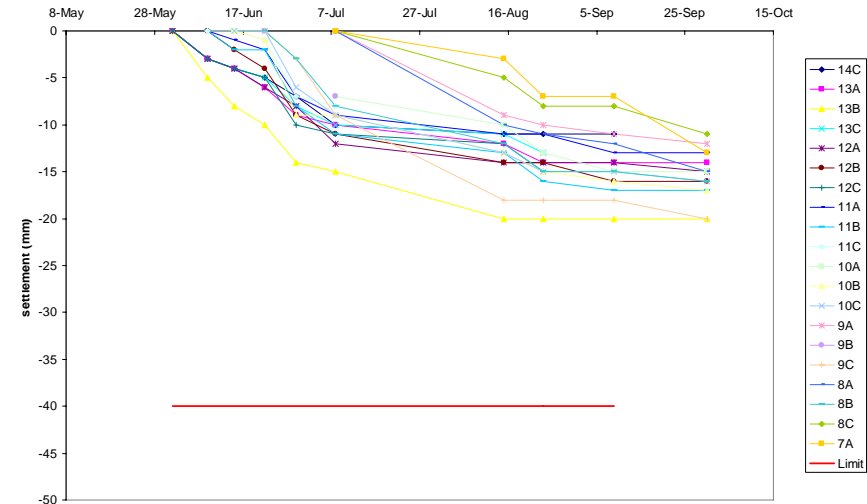
Settlement monitoring parking garage Civic Tail

HR	1-Jun	1-Jul	8-Jun	15-Jun	22-Jun	29-Jun	6-Jul	13-Aug	20-Aug	27-Aug	3-Sep	14-Sep
14C	0.000	0.000	-3	-4	-5	-7	-10	-11	-11	-11	skid	
13A	0.000	0.000	-3	-4	-8	-9	-10	-12	-14	-14	-14	-14
13B	0.000	0.000	-3	-4	-10	-14	-15	-20	-20	-20	-20	-20
15C	0.000	0.000	-3	-4	-5	-6	-8	-11	-11	-11	skid	
12A	0.000	0.000	-3	-4	-8	-9	-12	-14	-14	-14	-14	-15
12B			0	-2	-4	-6	-11	-14	-14	-14	-16	-16
13C	0.000	0.000	-3	-4	-5	-10	-11	-12	-15	-15	skid	
11A			0	-1	-2	-7	-8	-11	-11	-11	-13	-13
11B			0	-2	-2	-8	-11	-13	-16	-16	-17	-17
11C			0	0	-1	-7	-8	skid				
10A				0.000	0	-7	-10	-10	-10	-10	-10	-10
10B				0.000	-1	-6	-9	-10	-10	-10	-10	-17
10C				0.000	0	-6	-9	-10	-10	-10	-10	-16
9A					0.000	-7	skid					-12
9B		0.000			0.000	-3	-6	-10	-10	-10	-10	-20
9C		0.000			0.000	-3	-6	-10	-10	-10	-10	-15
8A		0.000				0.000	-6	-11	-11	-11	-12	-15
8B		0.000				0.000	-6	-10	-10	-10	-10	-16
8C		0.000				0.000	-5	-9	-9	-9	-9	-11
7A		0.000				0.000	-3	-7	-7	-7	-7	-13

7B		0.000					0.000	-5	-6	-6	-6	-10
7C		0.000					0.000	-6	-6	-6	skid	
6A		0.000					0.000	-6	-7	-7	-7	-10
6B		0.000					0.000	-4	-4	-4	-4	-8
6C		0.000					0.000	-7	-11	-11	-11	-16
5A		0.000					0.000	-6	-6	-6	-6	-13
5B		0.000					0.000	-1	-1	-1	-1	-9
5C		0.000					0.000	-6	-10	-10	-10	-15
4A		0.000					0.000	-5	-6	-6	-6	-13
4B		0.000					0.000	-1	-1	-1	-1	-9
4C		0.000					0.000	-2	-2	-2	-2	-13
3A								0.000	-6	-6	-6	-11
3B								0.000	0	-7	-7	-12
3C								0.000	0	-8	-8	-12
2A									0.000	-3	-3	-8
2B									0.000	-6	-6	-11

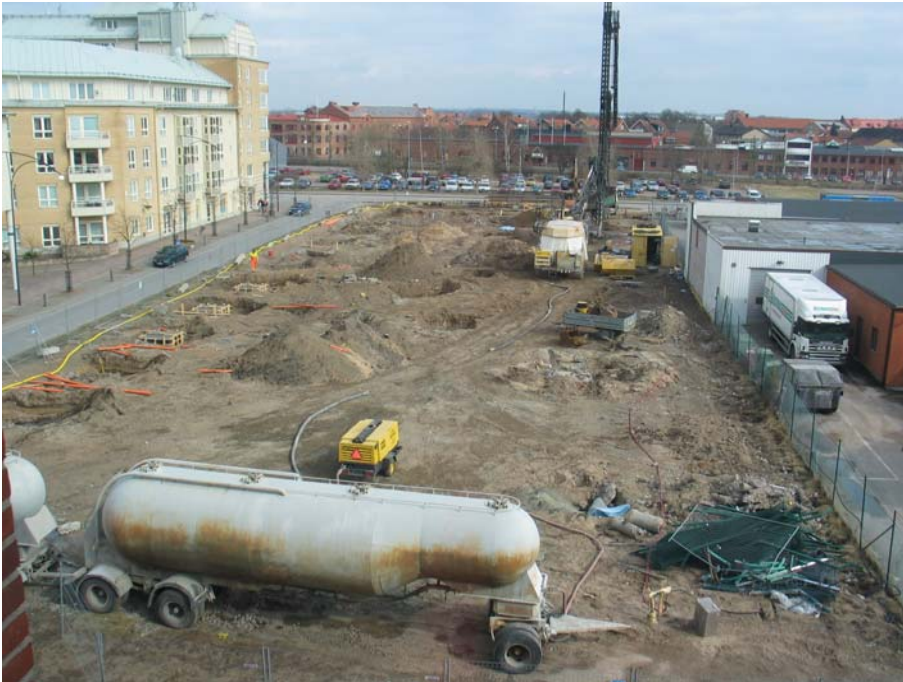
Parking House founded on MDM™ - columns

- Columns installed in blocks
 - 3 to 16 columns/block
 - 600 mm columns
 - 14 to 16 m length
- Column strength
 - Average 9 MPa
 - 3 to 17 MPa
- Column load
 - 250 to 300 kN
